## EROSION PROTECTION WORKS ALONG BANKS OF BRAHMAPUTRA RIVER - ROHMORIA, ASSAM

**MACCAFERRI ENVIRONMENTAL SOLUTIONS PVT. LTD.**

**BRIEF:**

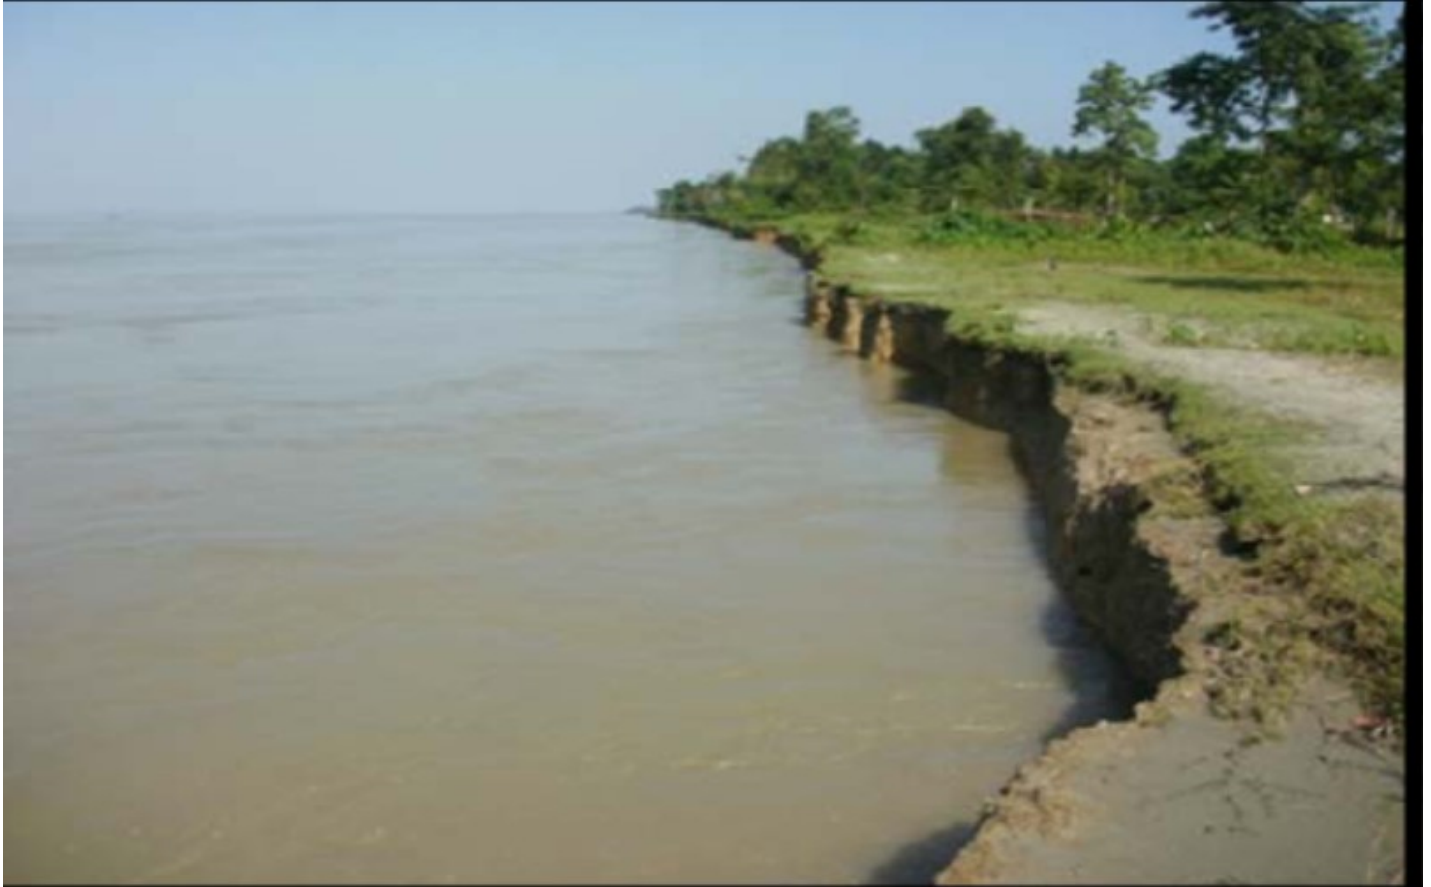
**Scouring of the banks of the Brahmaputra River**

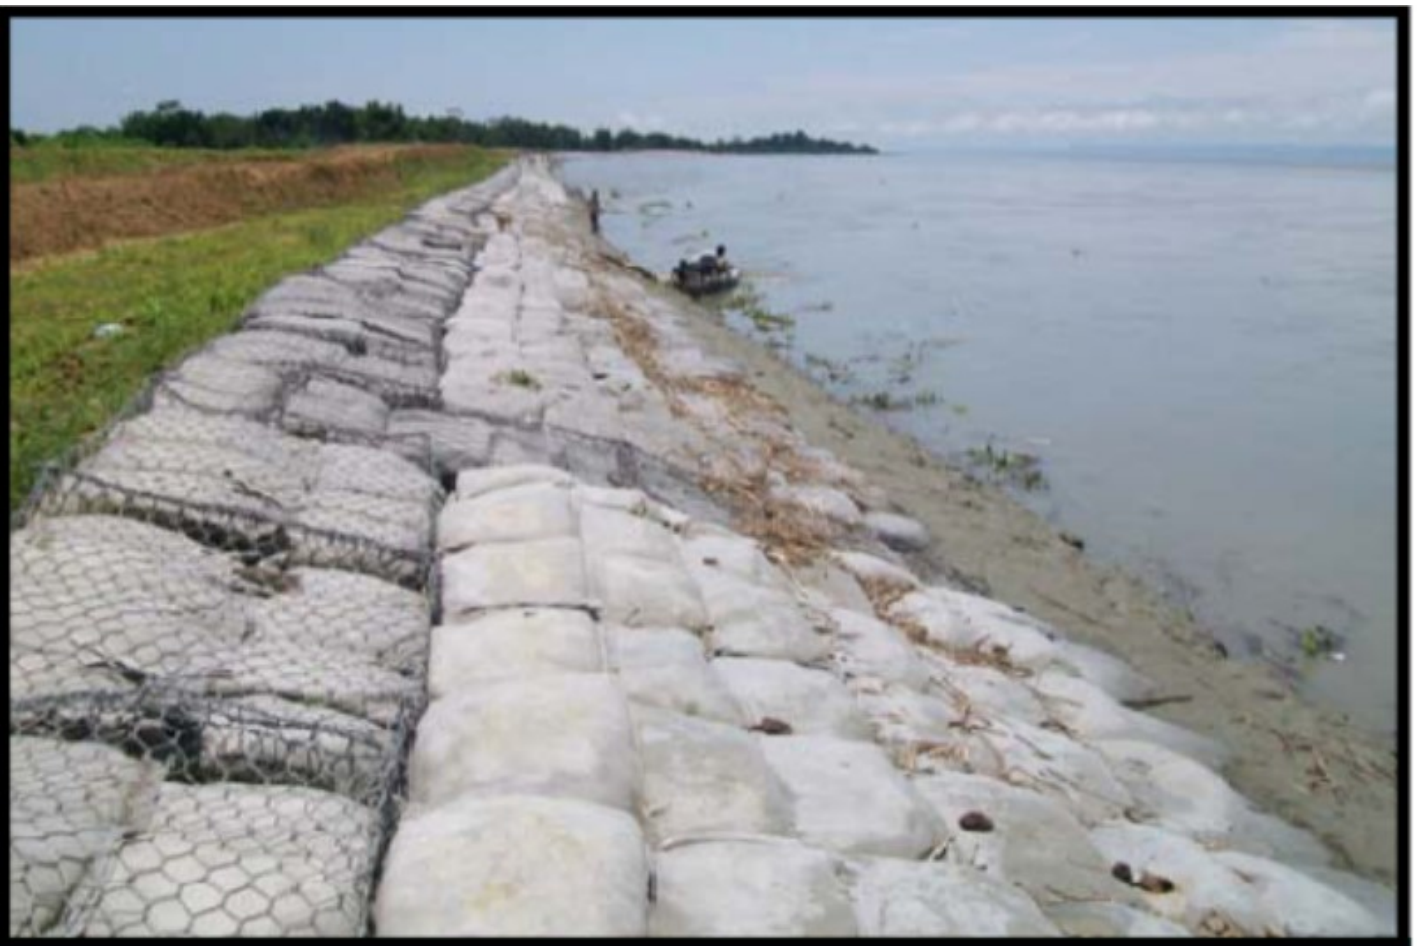
**Condition of Geotextile Bags & River Bank After Flood**

The scheme was proposed by Water Resources Department to protect bed and bank of river. Proper bank and toe protection works was the key to the system proposed. This was followed by well dressed bank slope and the height of slope was approximately 5.5m. The bank and bed protection were carried out with geotextile bags placed on geotextile filter layer. Peripheral strips of Steel Gabion and PP rope gabions filled with layers of geotextile bags were placed at regular intervals to impart further stability to the scour protection measure.

High quality Non woven Geotextile materials as a filter and separator to protect the bank slope beneath the Geotextile bag revetments. The PP rope gabions filled with Geotextile bags in two layers were installed at the toe of the slope excavation. The bank revetment was at a slope 1:3 so the bank slopes were trimmed at same slopes. The high quality Non woven Geotextile filter was then laid and Geotextile bags in three layered system were laid or placed on the slope. The PVC coated double twisted wire mesh gabions were used on the slopes in rib form which were also filled with Geotextile bags. Geotextile bags used were of lay flat sizes 1.03m x 0.7m and when filled with dry sand the bags weighed minimum of 126 kgs.
